HITTING A HOME RUN!! --- A CONDENSER SUCCESS STORY

Dave Leissner
Mirant
Chalk Point Generating Station
Aquasco, Md
david.leissner@mirant.com

Abstract:

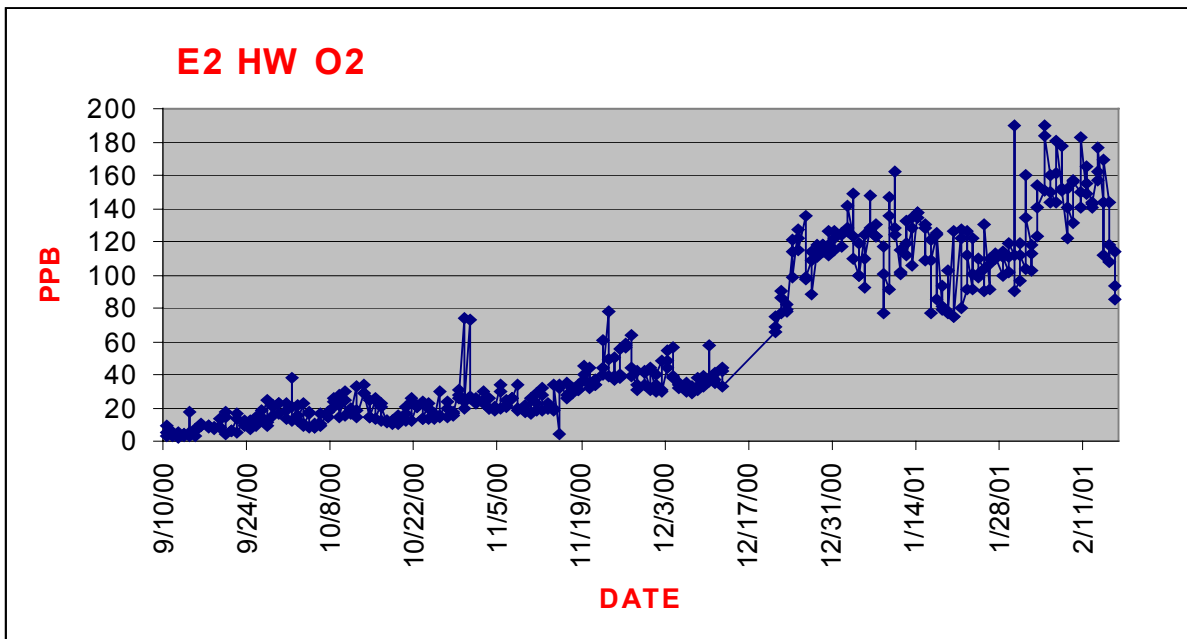
Below is a graph of the gradual increase in Hotwell dissolved oxygen beginning in Sept. 2000:

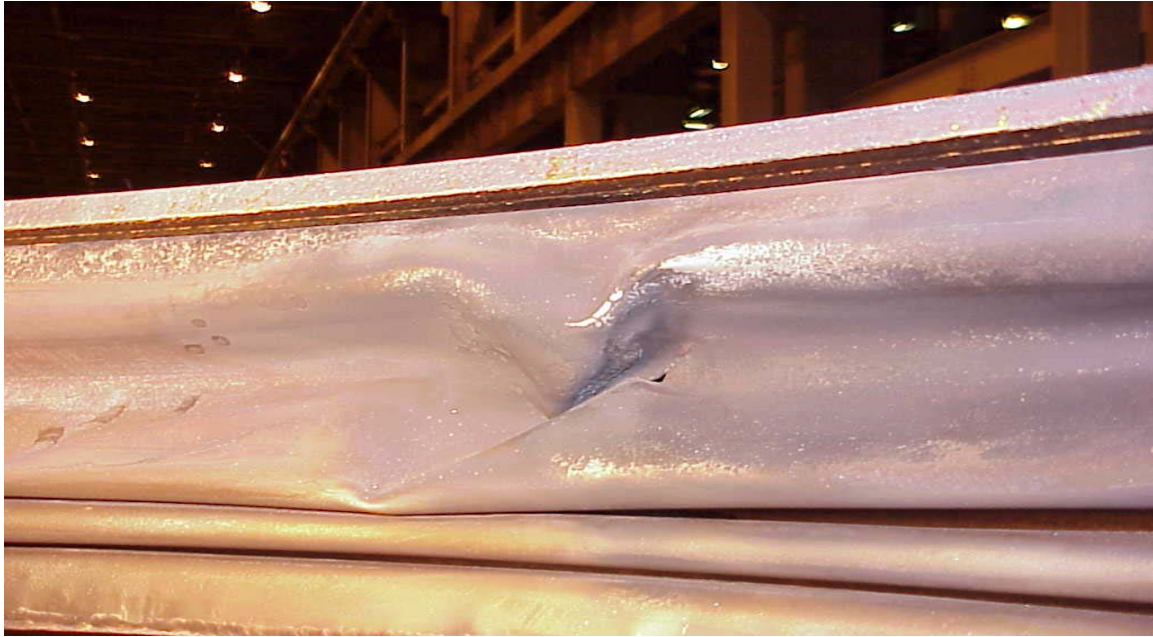
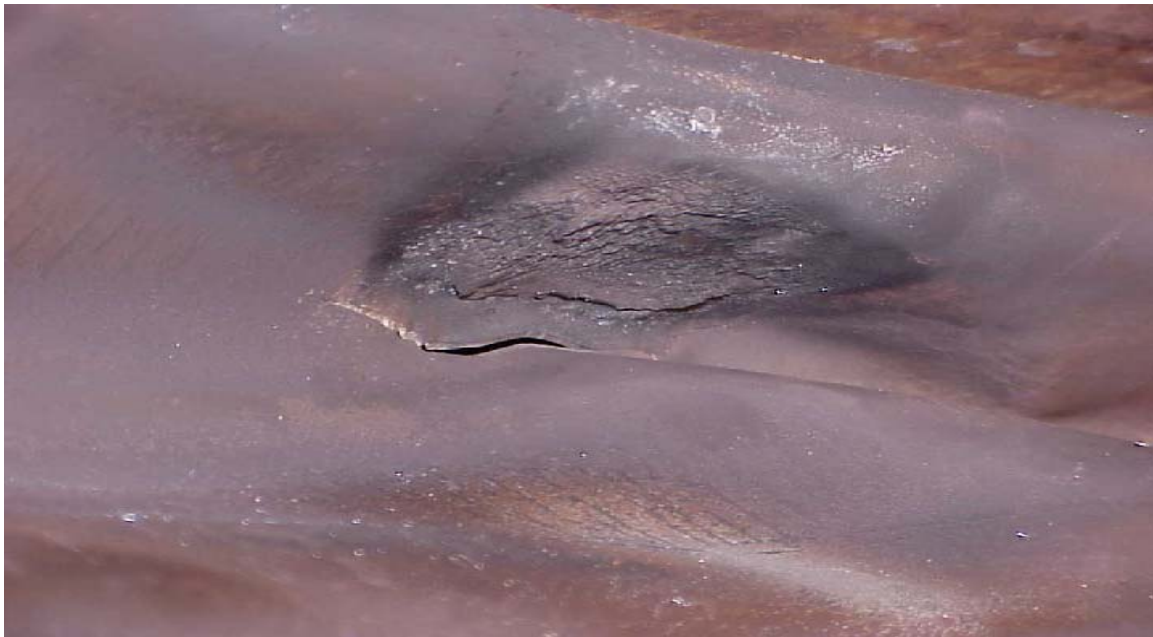
LOW PRESSURE CROSSOVER JOINTS:

The helium testing confirmed the theory that the air leakage had to be coming from above the expansion joints and located the leaks on the turbine deck. The major leaks of the cross-over expansion joint and the steam seals on the low pressure turbine were definitely large enough to cause problems with the heat transfer to the condenser tubes due to air leakage. The response times of these leaks was almost instantaneous, it took less than 20 seconds for the helium to arrive at the sample point just downstream of the silencer, which is located approximately 150 feet away from the air removal pumps.

Upon disassembly of the low pressure cross-over, significant damage to the bellows expansion joint was found. The pictures below indicate the actual damage that produced an over-range during the helium leak test of over 60,000 divisions.

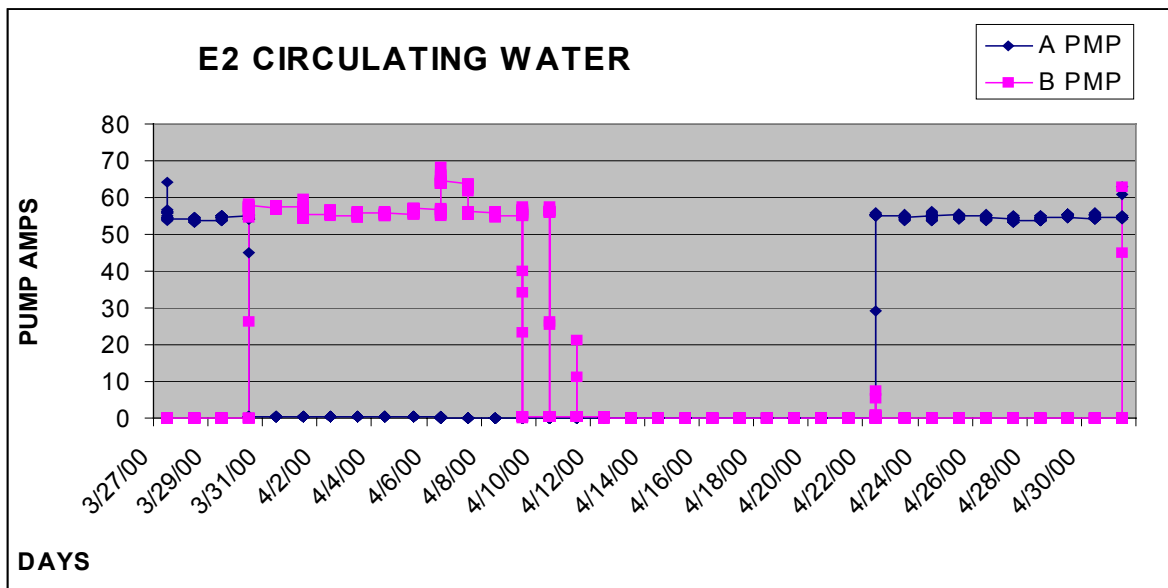
LOW CIRCULATING WATER FLOW CAUSES SILT BUILD-UP:

Although the condenser was cleaned using metal cleaners, the unit was not immediately returned to service due to the extended work performed during the overhaul. During this time, the circulating water system needed to be placed into service to support the auxiliary equipment in the plant. It was decided that in order to save on plant station service, that only one circulating water pump would be run on the condenser being placed into service. As a consequence, the tube water velocity fell to just 3.4 ft/sec, which is only half of its designed value. This condition led to accelerated silt build-up within the tubes. The following graphs indicate the length of time that each condenser was being operated with only one pump in service.

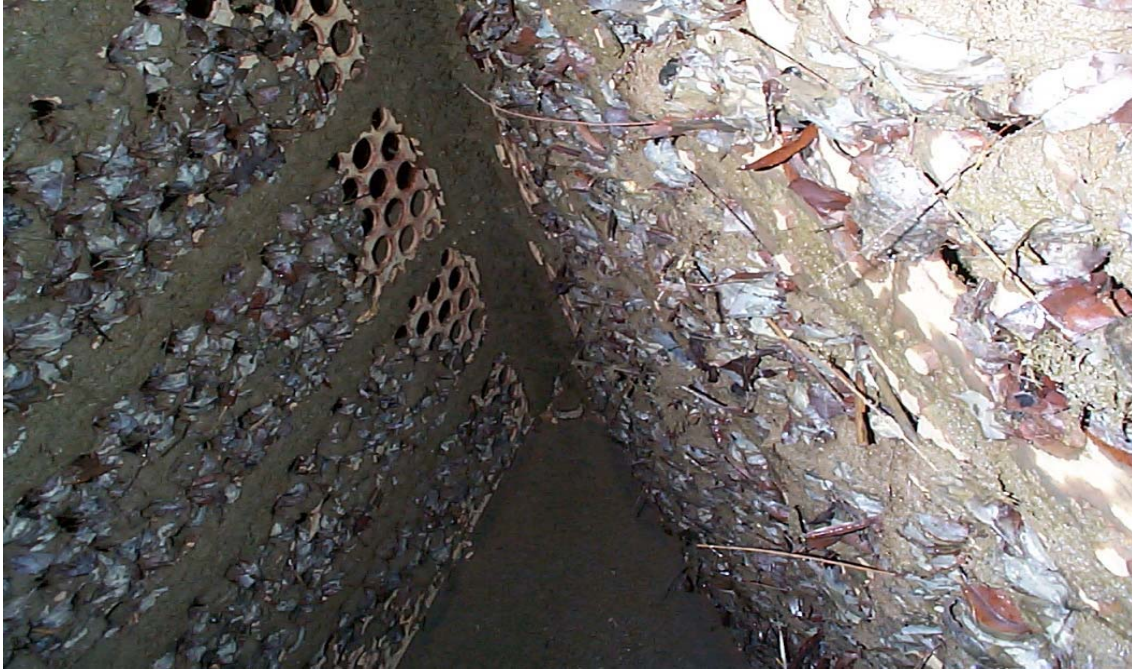
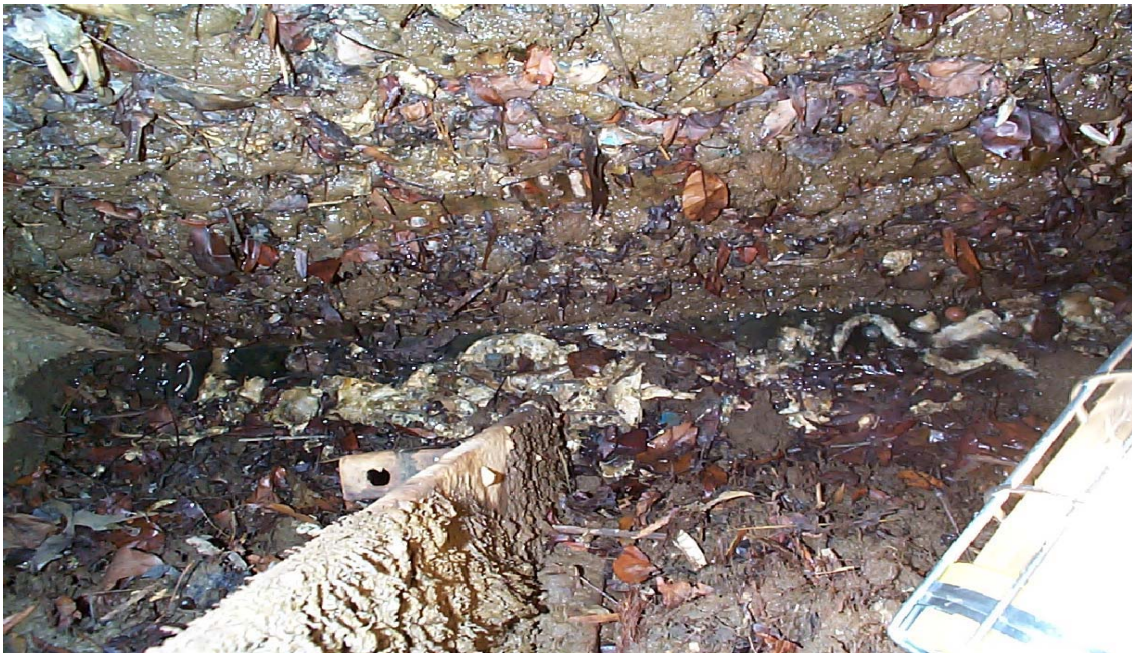
After returning to service from the overhaul, the condenser remained in service until October with no opportunity to clean the waterboxes of macro-fouling. The pictures below are an indication of the amount of debris and accumulation of growth that units 1 and 2 see every summer. Since being forced to reduce and replace the chlorine injection with non-chlorinated circulating water treatment, the amount of macro-fouling due to garvia has increased dramatically. The injection rates of the sodium hypochlorite are currently being increased and under study in order to reduce the amount of garvia growth. As illustrated in the picture, when we are not fighting garvia, leaves become a serious concern in the fall.
