POWER

Innovative Cleaning of Air Preheater Coils with Pressurized Liquid Nitrogen

By **Al Hovland, PE**, Conco Systems Inc.; **Frank G. Lyter, PE**, PPL Generation LLC; and **Charles Truchot**, Air Liquide.

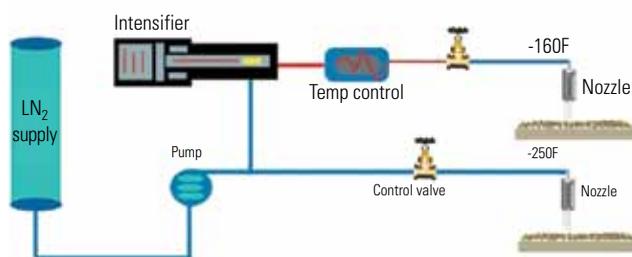
1. The NitroLance process. Source: Conco

The NitroLance cleaning system delivers pressurized liquid nitrogen to the cleaning surface and rapidly removes deposits through three mechanisms: mechanical pressure, thermal expansion, and supercooling. The typical NitroLance process flow is illustrated in Figure 1. Commercial,

high-purity liquid nitrogen (LN₂) at -321F is pressurized to between 5,000 psi and 55,000 psi. Then, using a temperature controller, the LN₂ is directed onto the surface to be cleaned, while expanding about 700 times as it vaporizes. The controlled flow and temperature is regulated between -160F and -250F. The complete system is mounted on a mobile platform that is moved to close proximity of the heat exchangers being cleaned (Figure 2). The NitroLance hose and nozzle extend up to 300 feet from the mobile platform.

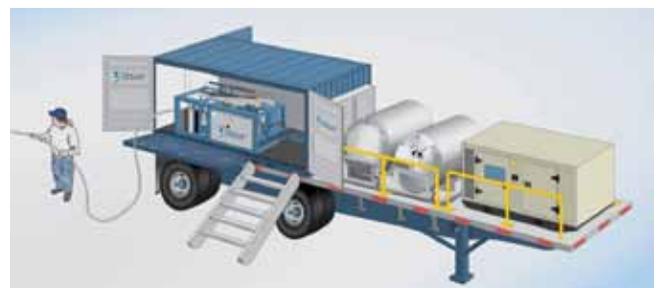
2. Mobile cleaning system. The NitroLance mobile platform arrives with LN₂ tanks, pumps, and temperature controller ready for work. Courtesy: Conco

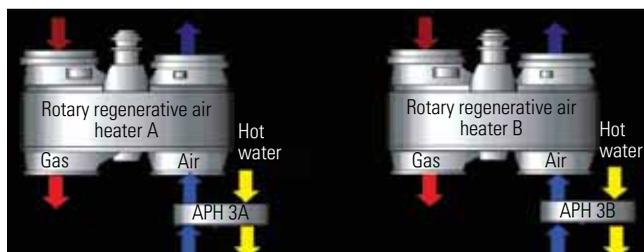
3. Heating air. In many coal-fired plants, rotary regeneration air preheaters (APHs) are supplemented with a steam coil air heater. At PPL's Brunner Island Power Plant, Unit 3 is configured with an "A" and a "B" steam coil air heater. *Source: Conco*

LN₂ cleanings were conducted at PPL Generation's Montour Power Plant in Washingtonville, Penn., and then at Brunner Island Power Plant in York Haven, Penn. Both of these plants use rotary regenerative Ljungström APHs. Upstream of the APH are finned tube steam coil air preheaters (Figure 3).

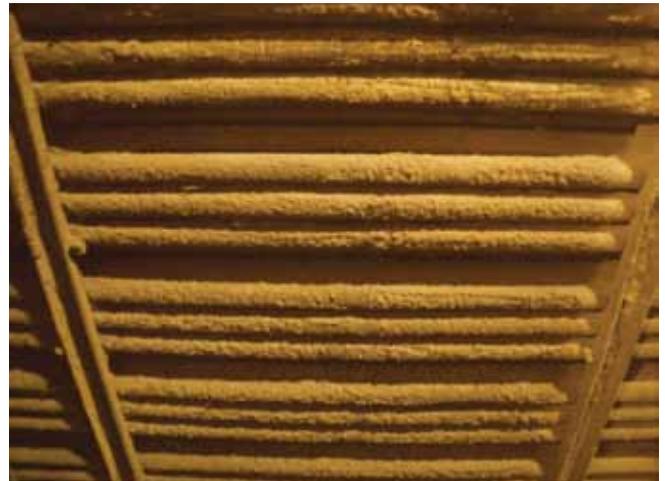
The finned tube air preheaters often fouled after a few years of plant operation. Additionally, cleaning of the rotary APH located above caused debris to fall onto the steam coil surface that must then be cleaned. At PPL's Brunner Island Unit 3, a 760-MW coal-fired unit, the fouling was due to fly ash deposits, dust/debris, and lube oil that had formed a thick shell over the fin coil surfaces. Because this unit is typically base-loaded, PPL prefers to conduct APH maintenance only during scheduled outages.

4. Fouled tubes. The "B" steam coil air heater tubes in "as-found" condition prior to cleaning. *Courtesy: Conco*

Previous APH cleaning with water, chemicals, and detergents was ineffective in removing tenacious deposits of fly ash and oil (Figure 4). During operation, the fouling restricted combustion airflow to the boiler through both the "A" and "B" sides. This reduced airflow through the air heater often limited power output during certain weather and other operating conditions. As an outage approached for the unit in spring 2010, the Conco NitroLance system was evaluated by PPL engineers and was then scheduled for cleaning the fouled "B" side air preheater coils.

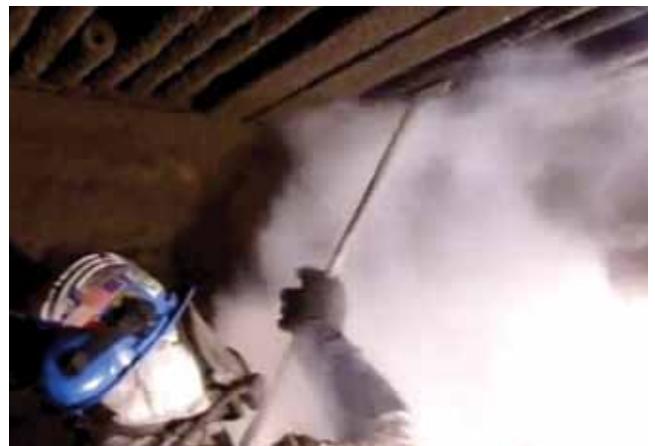
5. Proper attire required. A Conco technician, suited up with full-face respirators (with external air), rubber boots, and cryogenic insulated gloves, is cleaning the Brunner Island Unit 3B steam coil air heater. *Courtesy: Conco*

At the start of the unit's outage, Conco technicians, equipped with full safety gear—including jump suits, full-face respirators (with external air), rubber boots, and cryogenic insulated gloves—went into the air preheater coil ducts and quickly cleaned a portion of the fouled tubes (Figure 5). The system's delivery pressure was carefully adjusted to make sure that the heat exchanger's delicate tube fins (0.012 in. thick) were not damaged.

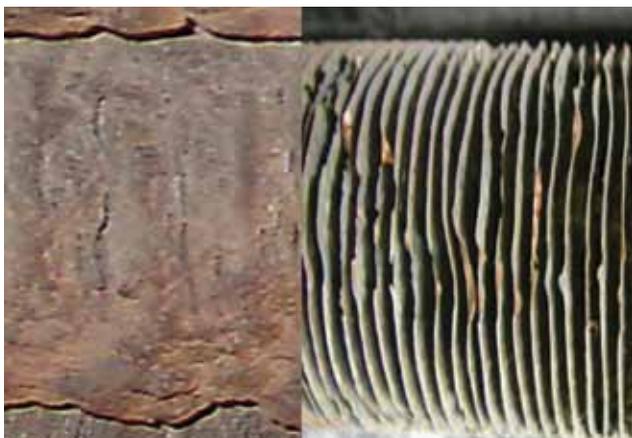
6. Thorough cleaning. The Unit 3B air preheater coils are shown before and after cleaning with LN₂. For perspective, the tubes are 2.5 inches in diameter with 1/2-inch fins attached at 14 fins/inch. *Courtesy: Conco*

The fly ash and oil deposits were removed in seconds, and a majority of the "B" air preheater was cleaned in only 12 hours (Figure 6). No damage was done to the fins by the LN₂ cleaning.

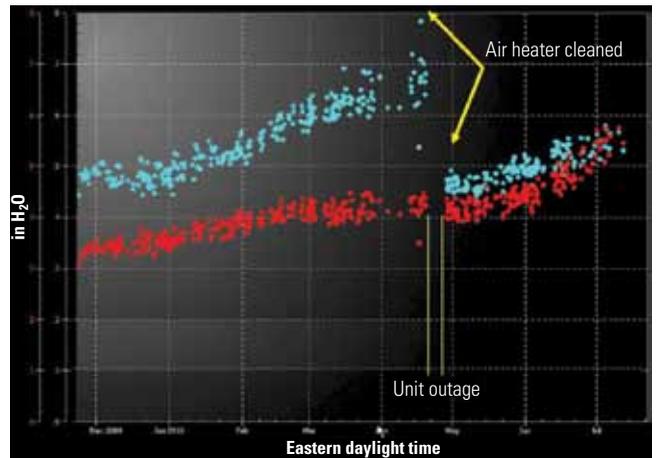
After the unit was brought back in service at the conclusion of the outage, improved plant performance was immediately apparent. Airflow blockage on "B" side was significantly reduced, and the airflow pressure drop across the air heater was reduced by half (8 inches H₂O to 4 inches H₂O). Although it was still higher than the original design airflow pressure drop (1.7 inches H₂O), the improvement was significant considering that only a portion of the air heater was cleaned due to limited time. Further improvement in the gas side pressure drop is expected after cleaning 100% of the preheater coils (Figure 7).

7. Performance pickup. After the 3B air preheater coils were cleaned, the reduced combustion air pressure drop translated into improved performance. The blue data points represent the Unit 3B air heater performance before and after the unit outage, during which the coils were cleaned. The red dots show the pressure drop through the 3A heater. *Source: Conco*

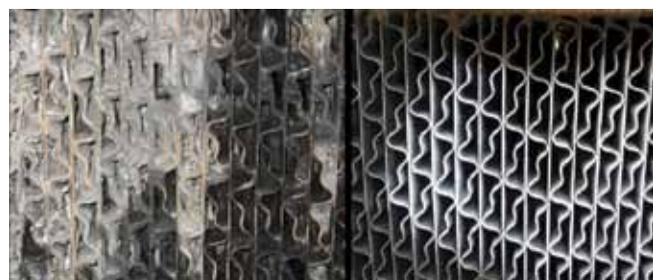
8. Basket cleaning. NitroLance cleaning on Ljungström baskets has also proved effective. Shown is a sample basket before and after cleaning. *Courtesy: Conco*

Conco Systems is now working with PPL to test-clean sample regenerative air heater baskets. Results from cleaning baskets taken from the Montour plant's Ljungström unit showed that the baskets were restored to a very high level of cleanliness (Figure 8). Cleaning the rotary air heaters' lower-end baskets in-place during an outage is possible if suitable space between the steam coil air heater and most primary air heaters is available. ■
