Nuclear Plant Efficiently Removes Calcium Carbonate From Condenser Tubes

The South Texas Project (STP) Nuclear Power Plant in Wadsworth, Texas, was put into operation in 1988. The plant has two condenser units, acting as heat exchangers to condense the steam back into a liquid state after it passes through the turbines. It is imperative that the water/steam in its closed-loop system remain free of any contaminants to maintain integrity. Likewise, the 96,234 titanium condenser tubes in each of the two units should be kept as clean as possible to ensure optimal condensing efficiency. Makeup water for the circulating water system is pumped from the nearby Colorado River and sent to the facility's 7,000-acre, 18-foot-deep holding reservoir adjacent to the plant.

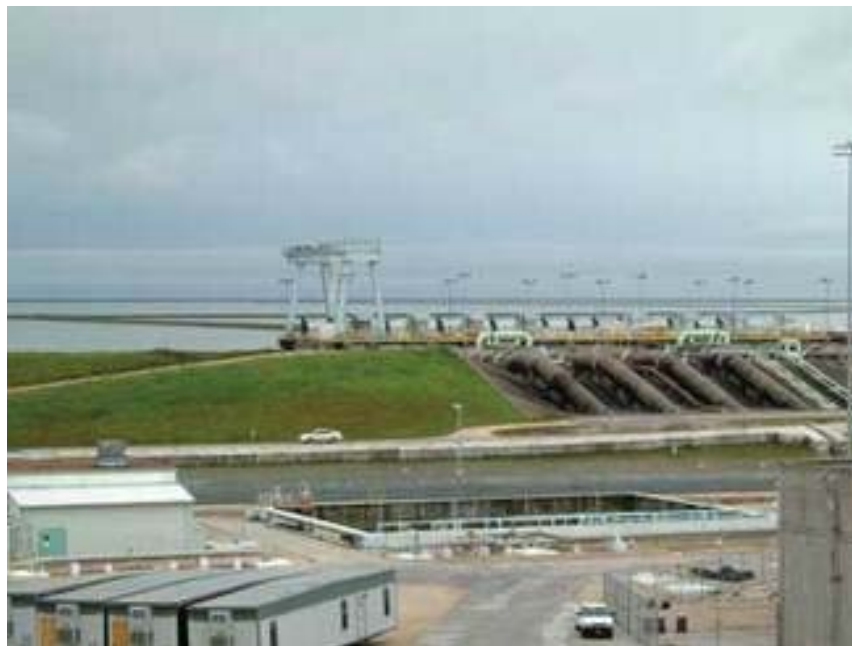
[STP's 7,000 acre reservoir with inlet pipes to the condensers are pictured here. Photo courtesy of Conco Systems Inc.](#)

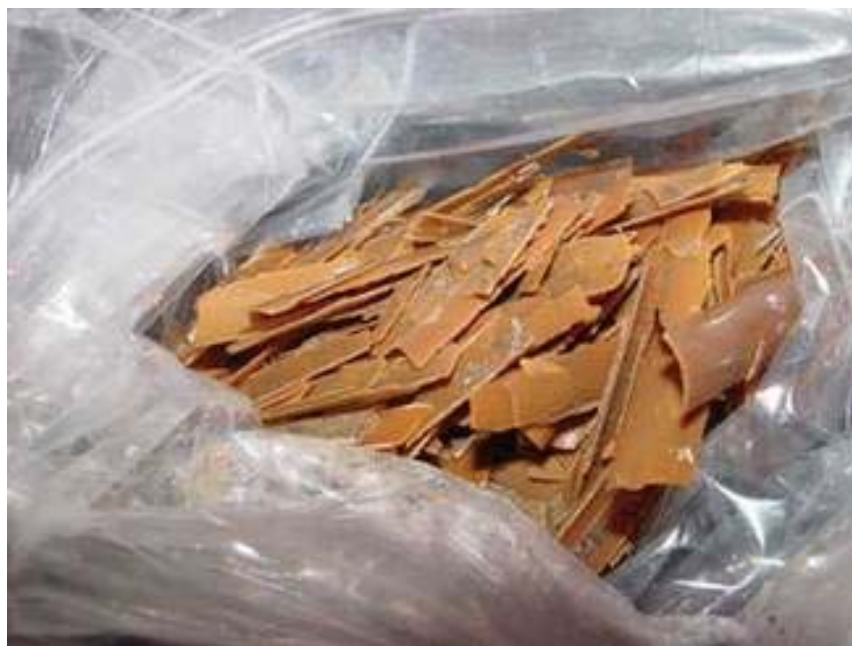
Calcium carbonate scale, however, poses a serious problem that, until recently, defied standard removal procedures. It is a crystalline compound found in such materials as limestone and marble. At STP, personnel tested 20 tube samples and determined the thickness of the calcium carbonate ranged from 7.6 mils to 31.2 mils, with an average of 19.06 mils. Some tubes were blocked completely.

[Pieces of the more than 8,000 pounds of calcium carbonate scale, pictured here, were removed from the tubes of STP's two condenser units. Photo courtesy of Conco Systems Inc.](#)

In all, seven-and-a-half cubic yards of calcium carbonate, weighing more than 5,000 pounds, was removed from the 96,234 condenser tubes in Unit 1. Shortly after, the same number of condenser tubes in Unit 2 were cleaned using the same method, and more than four cubic yards of calcium carbonate-weighing a little more than 3,000 pounds-was removed. STP personnel believe the tubes in Unit 2 were less fouled because they had been cleaned with metal-bladed mechanical tube cleaners in 2001, while the tubes in Unit 1 had been cleaned with nylon brushes that left ridges inside the tubes, promoting faster build-up of debris and scale.

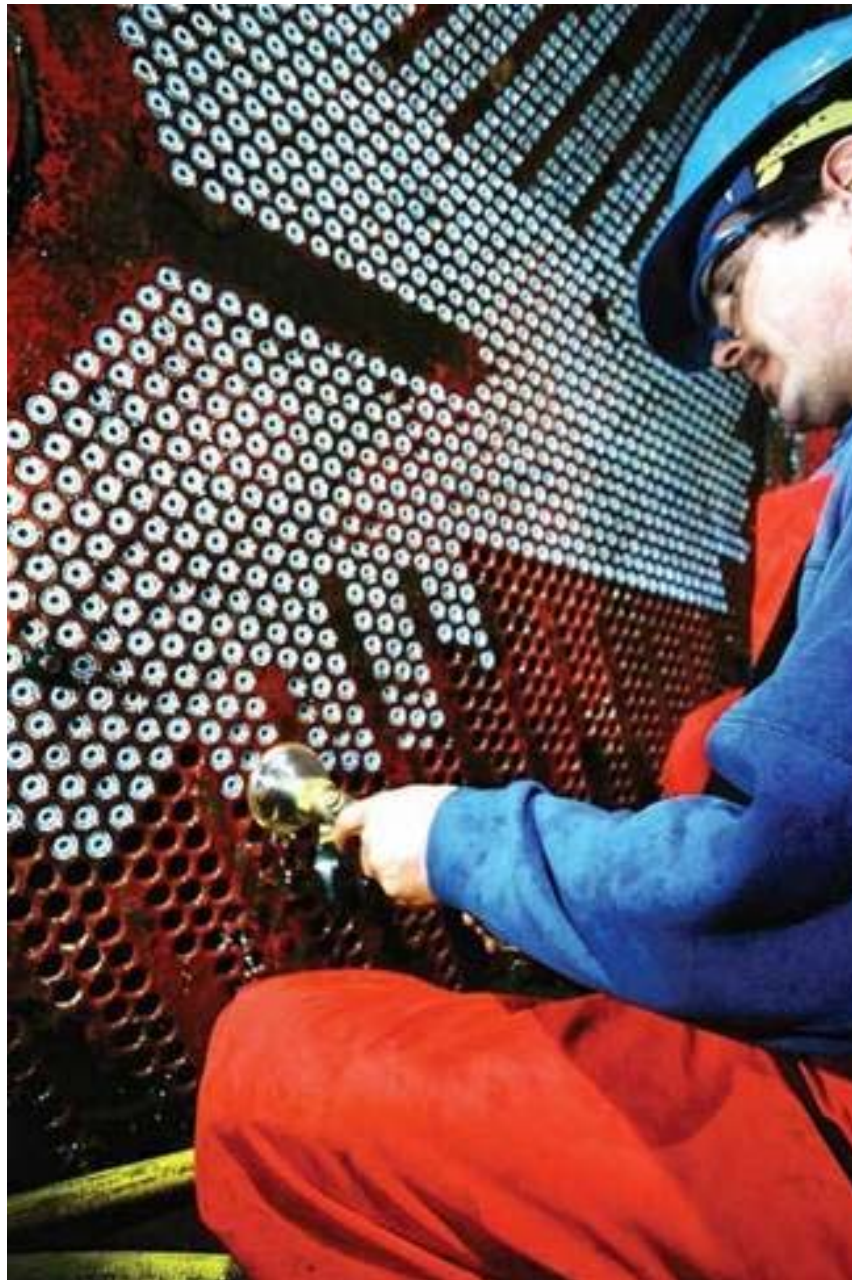
Following a bidding process, STP's management selected Conco Systems Inc. Conco Systems arrived on-site with a team of trained personnel and a supply of mechanical tube cleaners called "Cal-Busters," designed to break the stratified calcium carbonate deposits. The cleaner has two rows of four carbide wheels mounted through its circumference. These wheels act like glass cutters when they come into contact with the calcium carbonate scale.

[A technician shoots Conco "Cal-Buster" calcium carbonate cutting tube cleaners through the condenser tubes. Photo courtesy of Conco Systems Inc.](#)

Working in teams of eight operators per 12-hour shift, around the clock, it took approximately five-and-a-half days to clean each water box. Each team used four Conco Model 200B two-gun water pump systems that shot the tube cleaners with 200 to 300 psi water pressure. Three pumps were used on the inlet side and one was used on the outlet side when back-and-forth shooting was required to free the occasionally stuck cleaner.

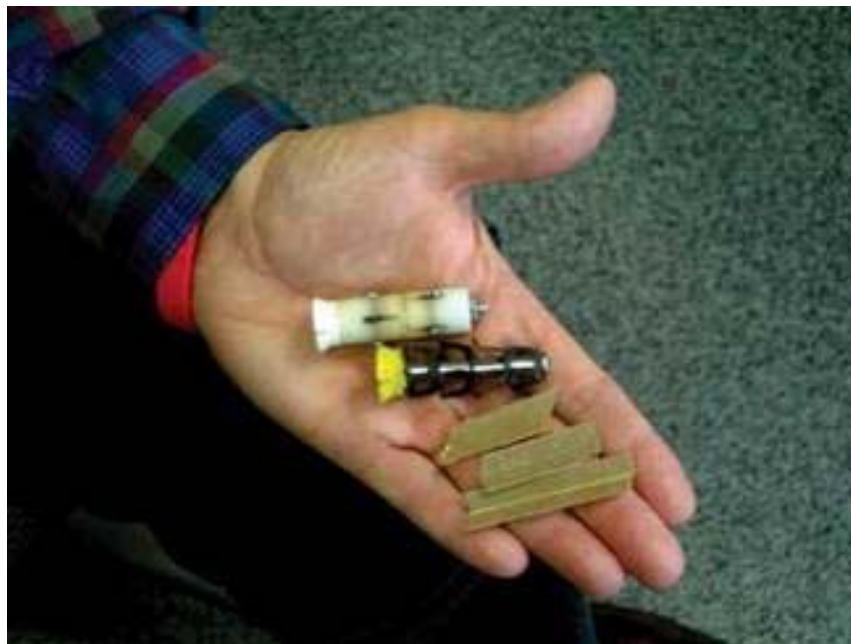
The team determined that the best cleaning procedure was going to be one pass with undersized Conco C4S metal-bladed cleaners, followed by multiple passes of various sized Conco Cal-Buster calcium carbide cutting cleaners, which are stepped in seven sizes for inside diameters ranging from 0.620 inches to 0.694 inches. After the scale had been fractured by the calcium carbide cutting cleaners, a final pass was made in each tube by a 0.694 inch metal-bladed Conco C4S mechanical cleaner to remove the fractured scale. After cleaning all the tubes in the water box, the team conducted a light inspection, which involved shining a bright spotlight down the tubes while performing a visual inspection from the opposite end. If the light was not evident, the tube in question was re-shot until it was fully open to water flow or it was marked accordingly for map plotting. During the light inspection, the team discovered that most tubes were clean, with little or no sign of scale and only a few tubes required plotting for future attention.

[Conco "Cal-Buster" calcium carbonate tube cleaner, Conco standard C4S type metal-bladed tube cleaner and calcium carbonate scale removed from one of the condenser tubes is pictured here. Photo courtesy of Conco Systems Inc.](#)
