HITTING A HOME RUN!! --- A CONDENSER SUCCESS STORY

Dave Leissner
Mirant
Chalk Point Generating Station
Aquasco, Md
david.leissner@mirant.com

Abstract:

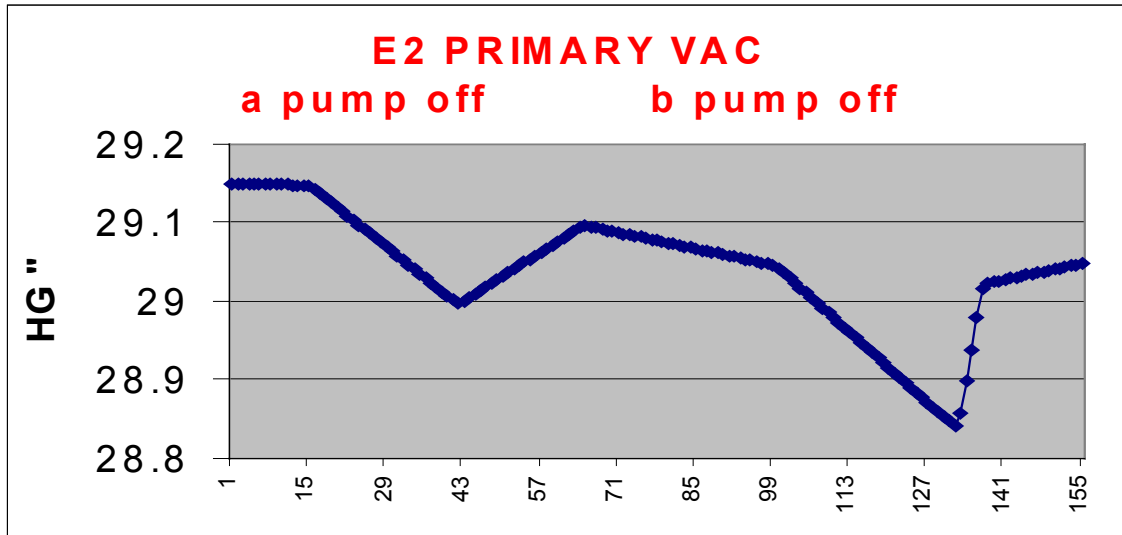
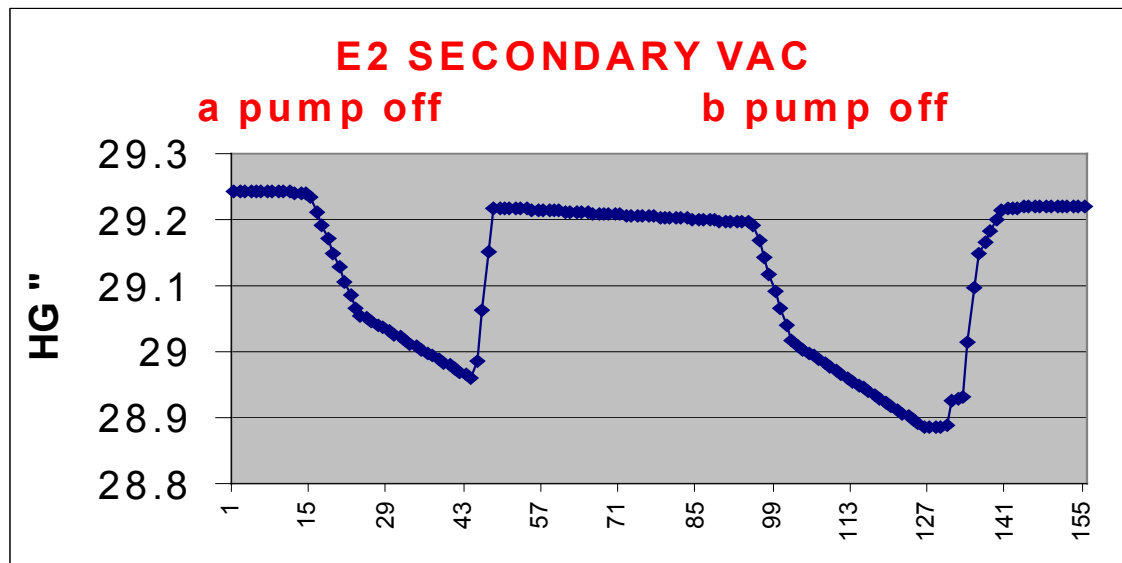
The following graphs indicate the vacuum response from a typical air removal pump test :

From the graphs above and the graphs on the following page, one would begin to make the conclusion that the B pump is removing more non-condensable gas than the A pump. Another tool that can be used to determine air removal pump condition is the trending of the motor amps of the pumps. It has been our experience that as a one pump begins to deteriorate, the amps on the motor decrease while the amps on the motor of the good pump increase. Trending of the air removal pump motor amps, along with the air removal pump testing, has been an accurate method of determining air removal pump condition.

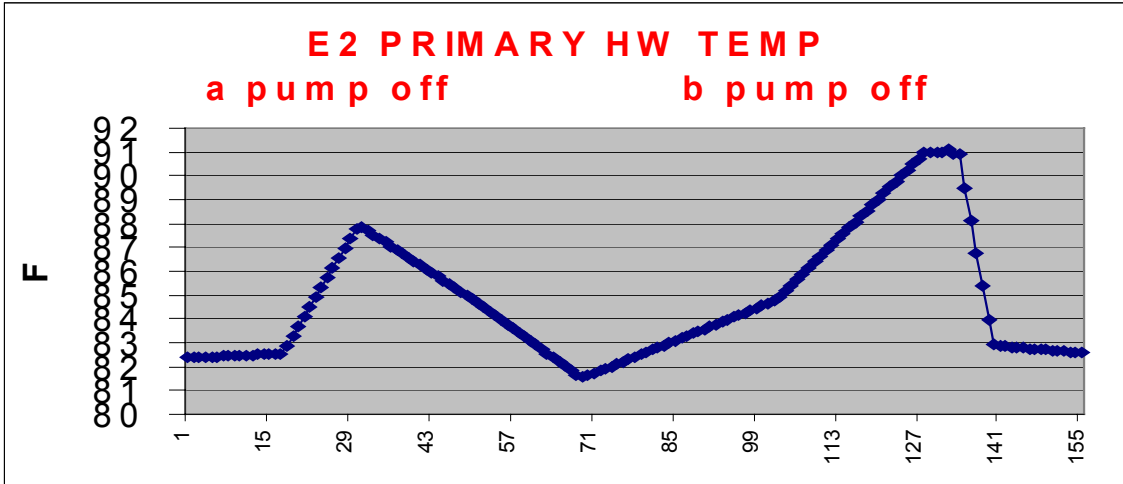
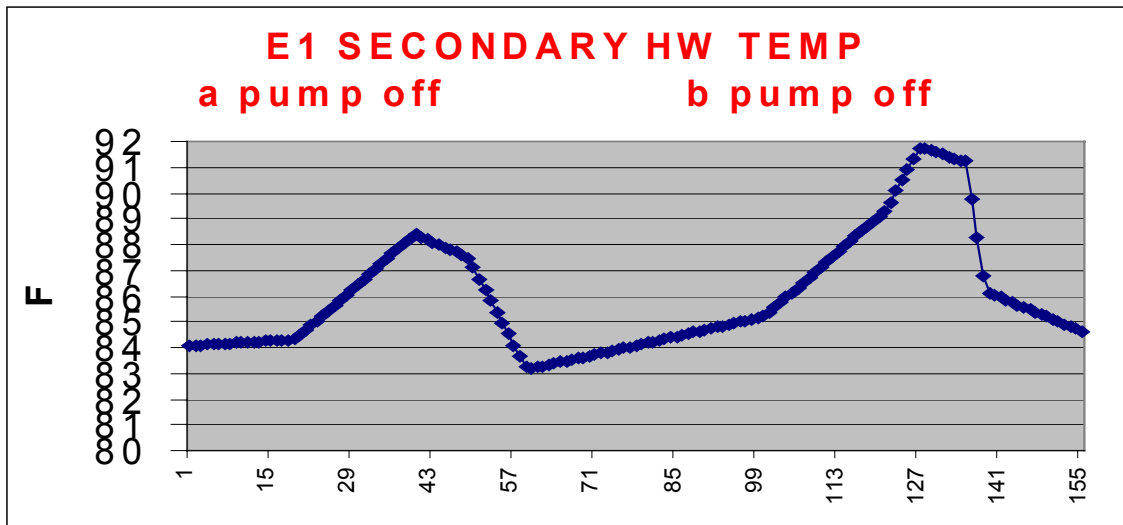
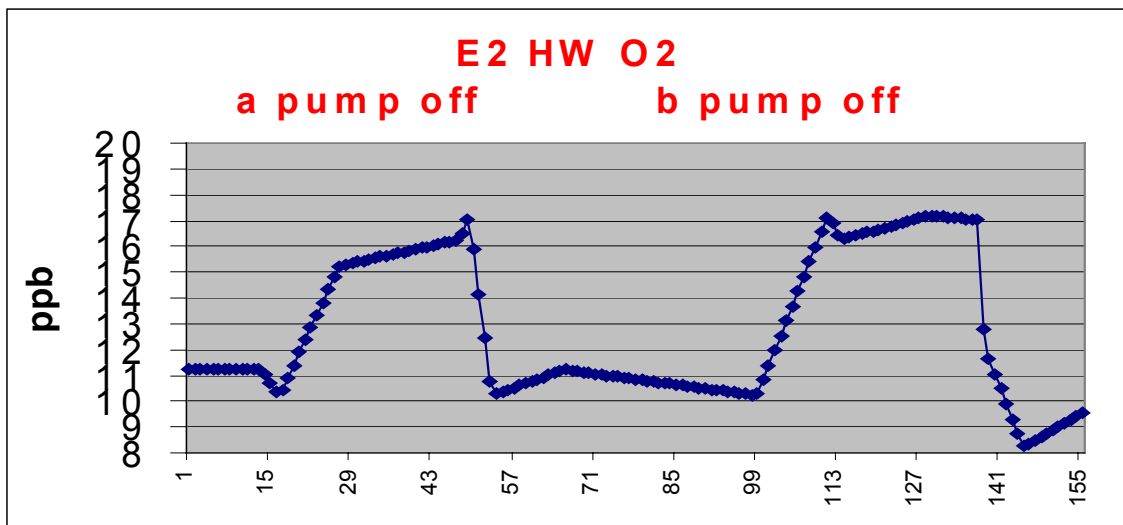
The graphs below indicate typical hotwell temperature and dissolved oxygen response when air removal pumps are taken off:

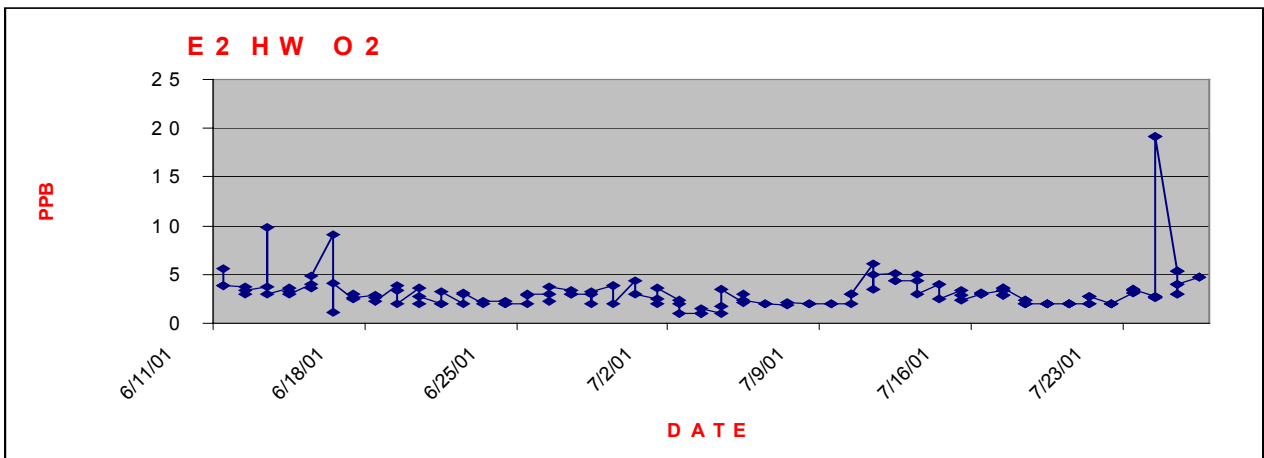
The air leakage rate on Unit #2 continues to be under control and the air removal pumps appear to be sufficient for removing non-condensable as evidenced by the following graph:

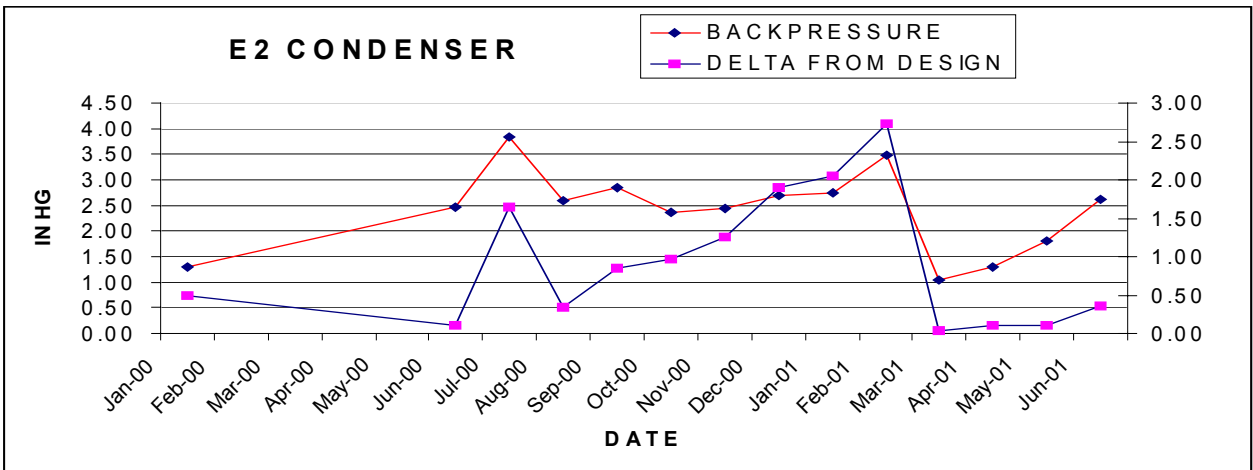
The chart below indicates the condenser performance before and after the overhaul. It should be noted that in February prior to the overhaul that the performance delta from design was +2.7 “ Hg.
